Refurbishment *Längshallen HB Zürich*

Introduction

- Main train station in Zürich, Switzerland
- Built in 1927-29
- Object listed as cultural heritage preservation canton Zurich
- Steel framework with wooden roof, rooflight and shed with wire glass, ribs with precast reinforced concrete elements and metal sheeting
- 6 halls with 14 railtracks involved
- Excluded: 1990-tees extensions at both sides
- Refurbishment under full operation

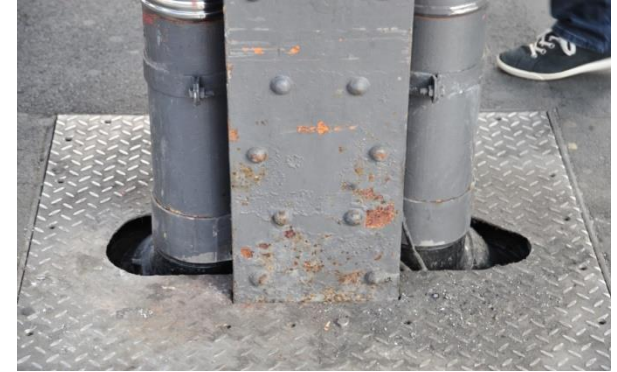
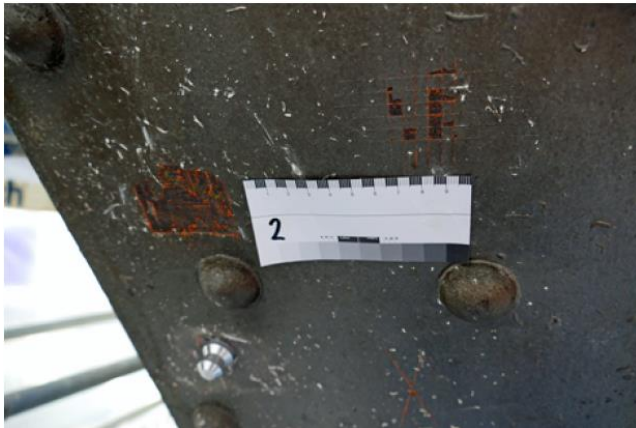
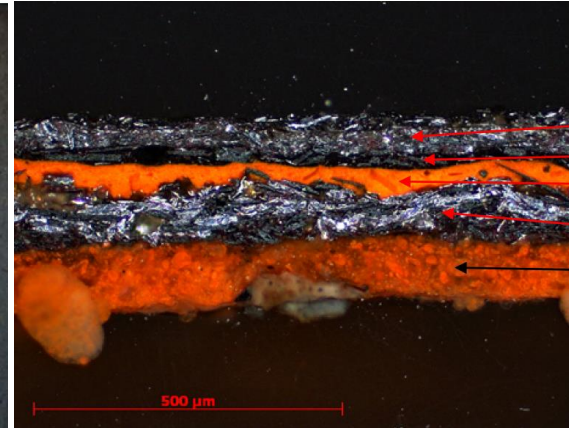
- Measurements at various spots
 - Aged protection system with sometimes doubled layer system
 - Containing Pb based mennige
 - Coating with various defects
- Treatment to be established with test arrays in collaboration with SBB-DPFL

- Cover 2 (alkyd resin)
- Intermediate (alkyd resin)
- Base 2 (mennige)
- Cover 1 (oil based)
- Base 1 (mennige)

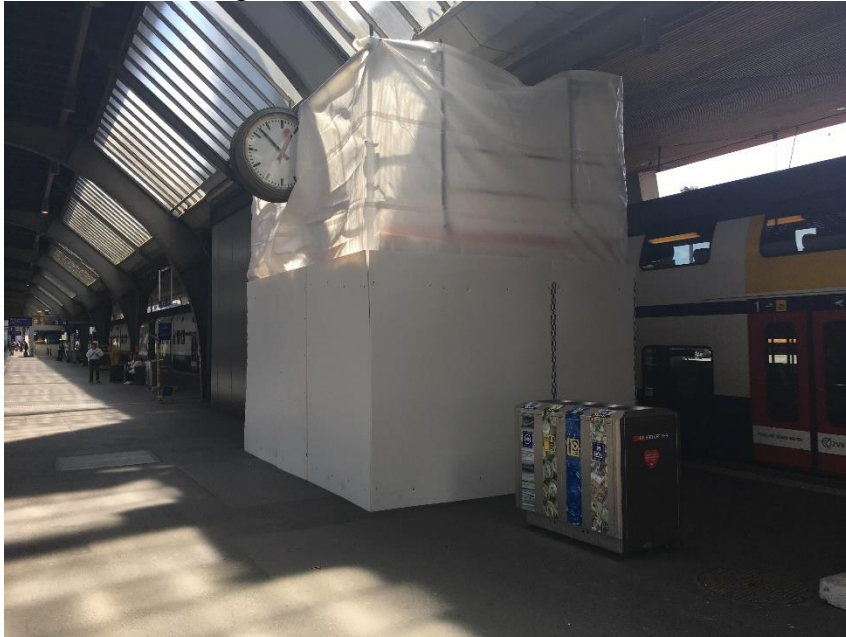
Enclosure of single column

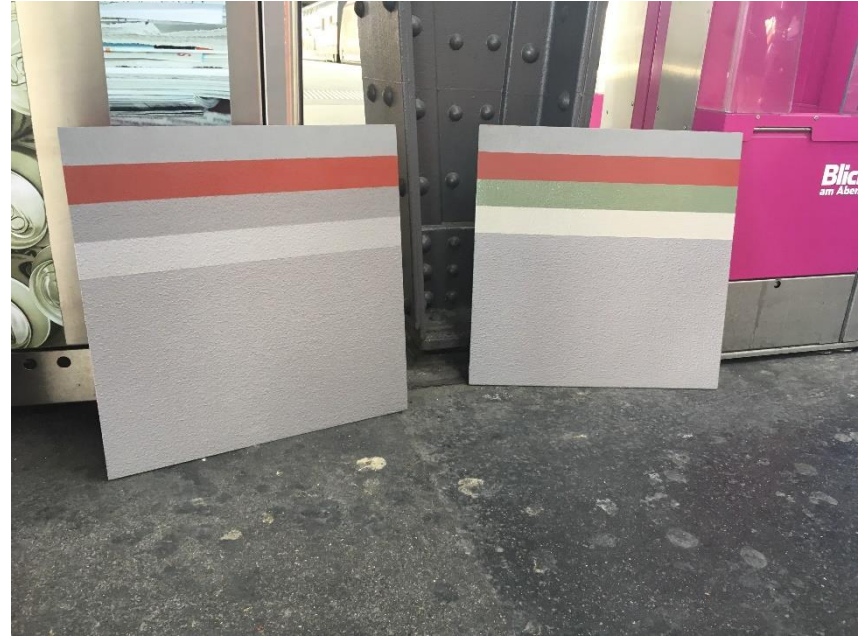
Test sample for final application method, i.e. brush vs roll

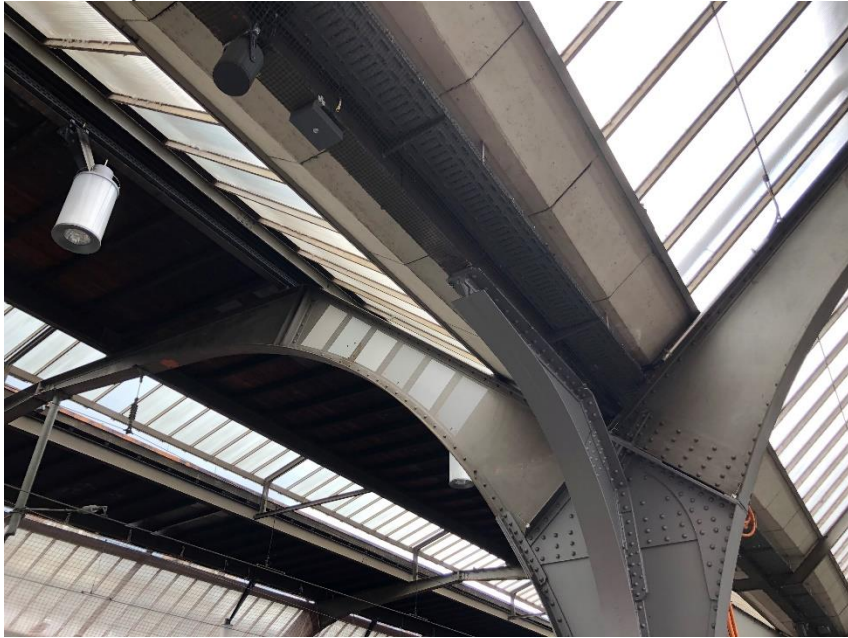
Test array for colour at beams

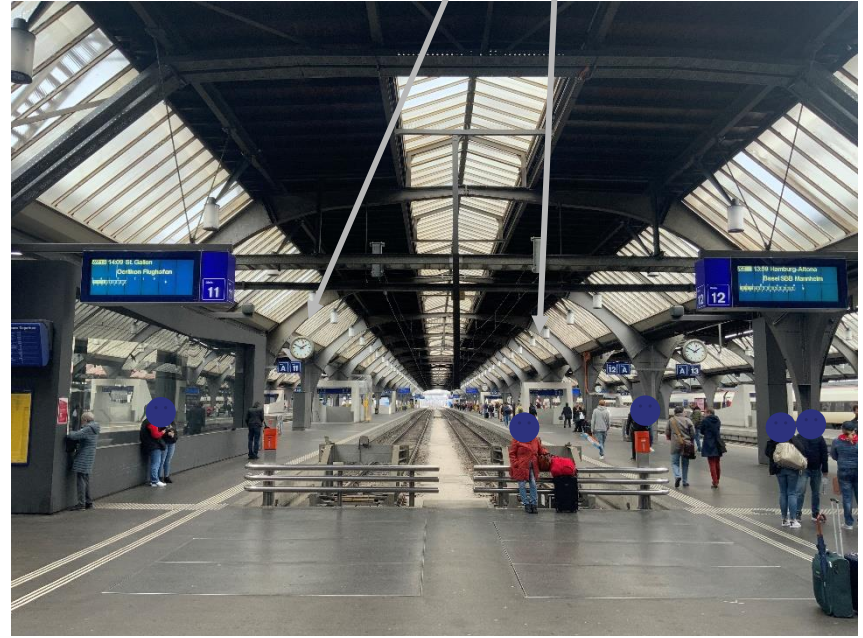
Appearance during process (old vs. new)

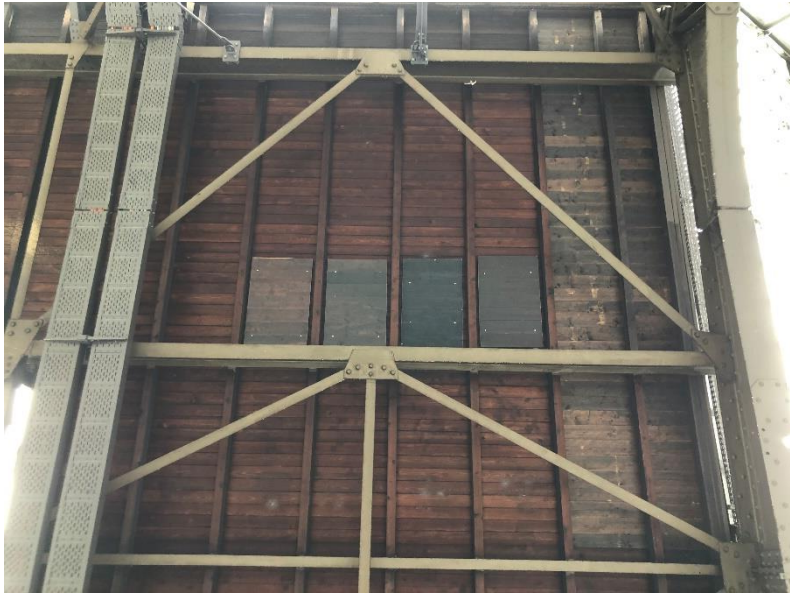
Color test array for replaced timber

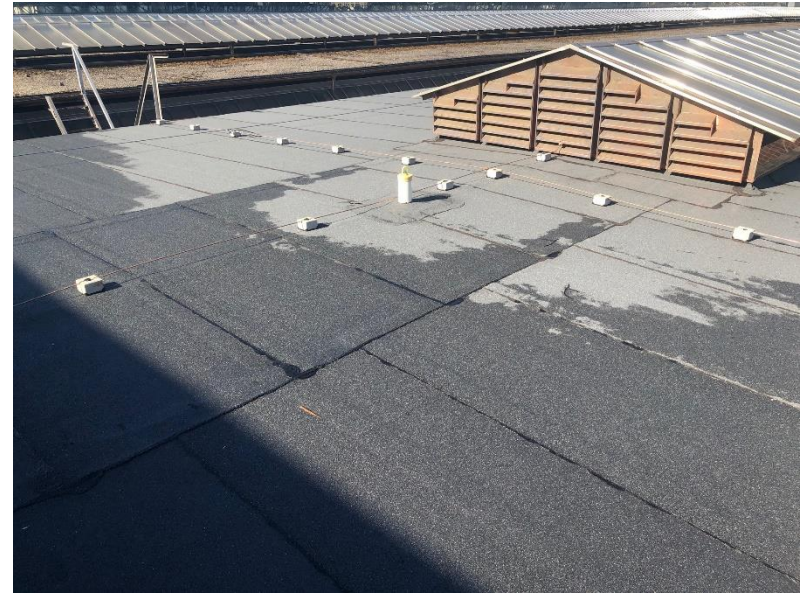
Finished roof incl. lifeline and lightning rod

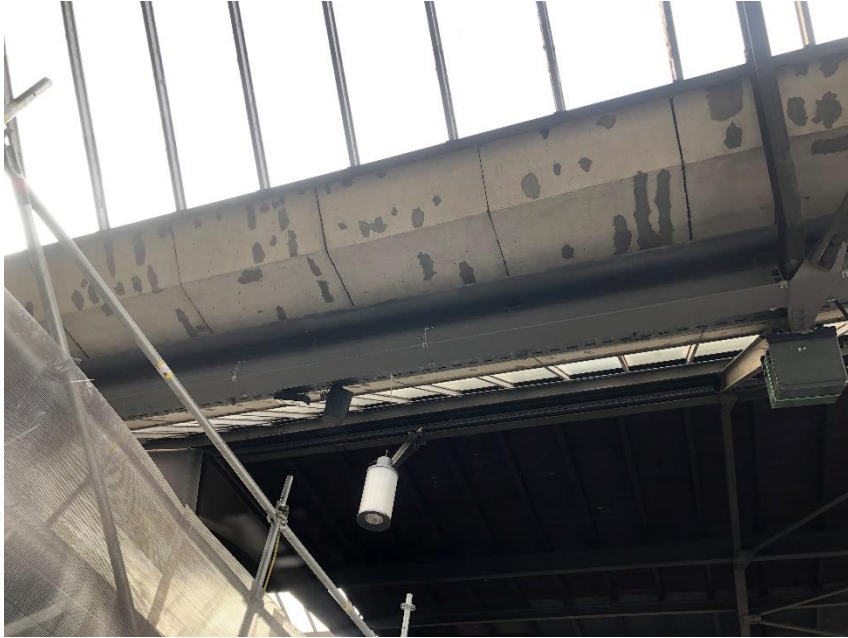
Appearance after local refurbishment

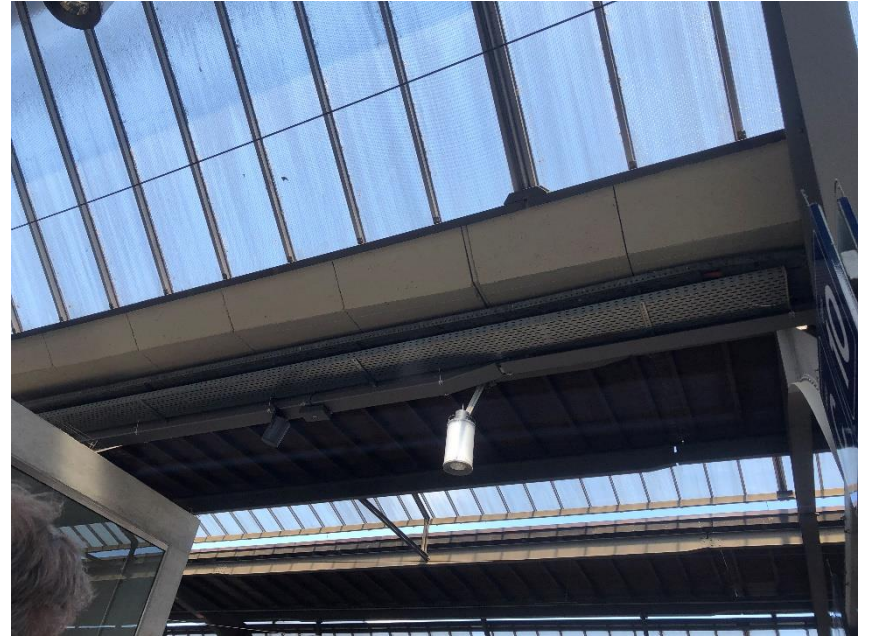
Appearance with surface cover
