Refurbishment *Längshallen HB Zürich*

Introduction

- Main train station in Zürich, Switzerland
- Built in 1927-29
- Object listed as cultural heritage preservation canton Zurich
- Steel framework with wooden roof, rooflight and shed with wire glass, ribs with precast reinforced concrete elements and metal sheeting
- 6 halls with 14 railtracks involved
- Excluded: 1990-tees extensions at both sides
- Refurbishment under full operation

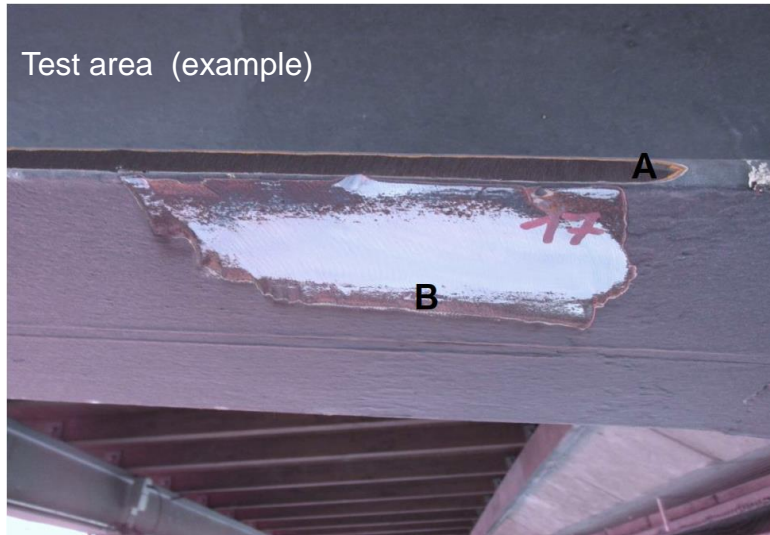
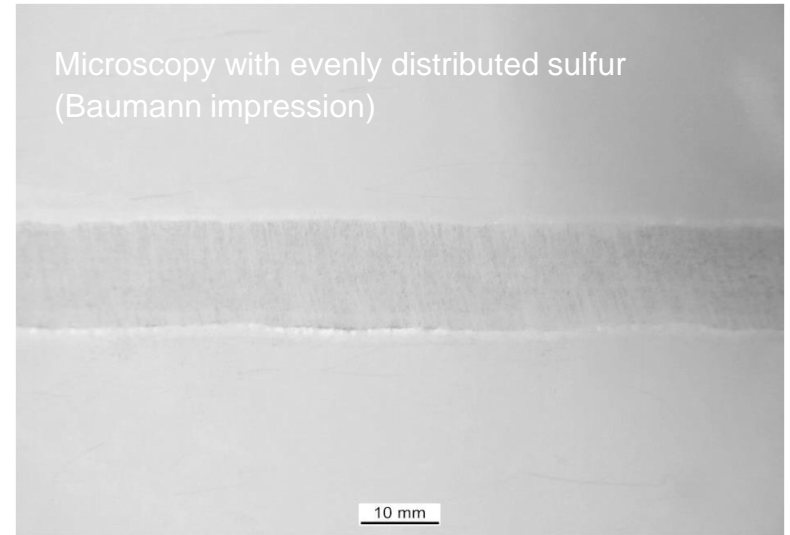
Steel – aging aspects

- Analysis of steel status including non-destructive testing (eddy current) and small samples
- No significant aging detected + mechanical properties approximated for usage in further calculations
- No actions required regarding steel structure

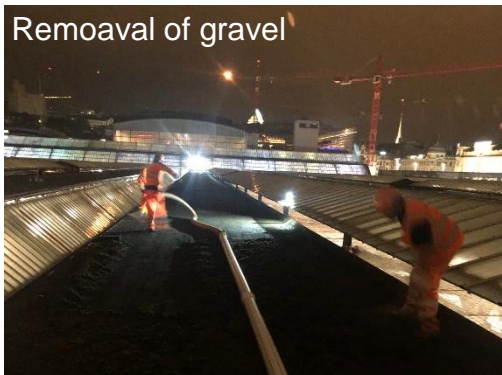
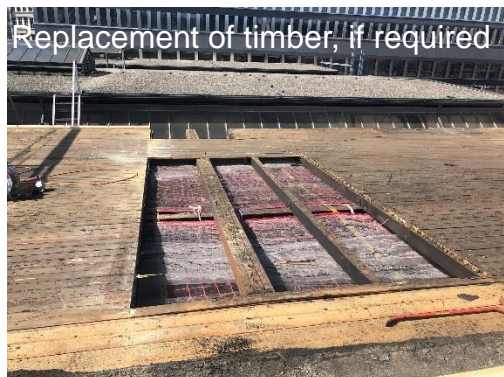
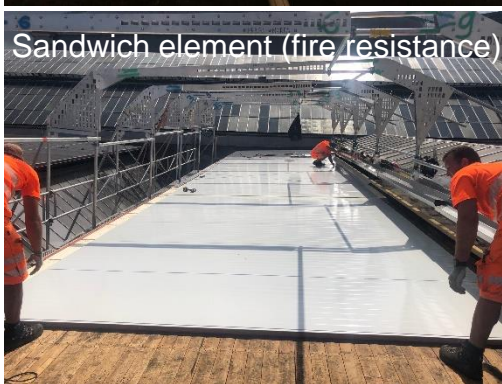
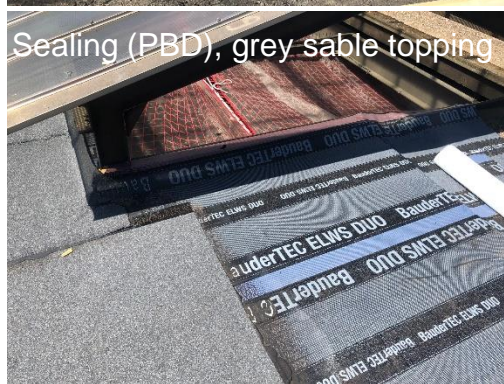
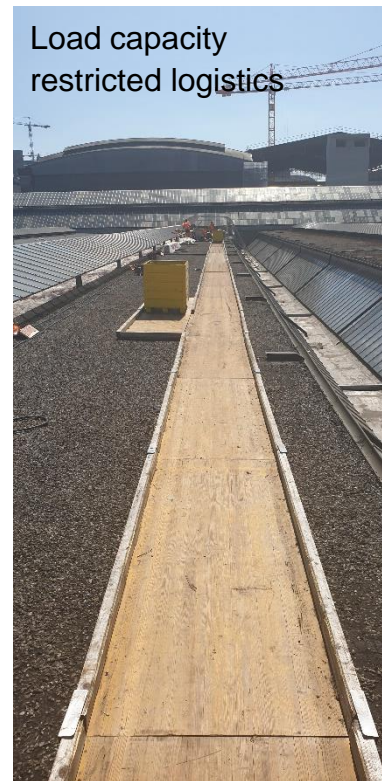
Wooden roof - impressions

- Load capacity
- Weight of roof (wood + sealing + gravel)
- Condition of timber (local)
- Condition of aged sealing
- Condition of ancient (wire) glas
- State of safety equipment
- Execution above platforms in use
- Execution near overhead contact line
- Load release with new roof system
- Definition of pathways during construction process
- Local replacement of timber
- Areal replacment
- Remaining, but considered into safety aspects
- New lifeline to attach personal safety equipment
- New lightning conductor
- Protection mesh, working at night if necessary
- SBB safety concept in place
